Client:	C/o Todd Architects
Project:	Tree survey for the proposed development at Cuirt Na Coiribe, Co.Galway.
Drawing Title:	Tree Constraints - Cuirt Na Coiribe

Client:	C/o Todd Architects
Project:	Tree survey for the proposed development at Cuirt Na Coiribe, Co.Galway.
Drawing Title:	Tree Constraints - Cuirt Na Coiribe
Drawn By:	HR
Checked By:	MG
CD File:	CNC-TS-001
Date:	22/10/18
Scale:	1:500@A1
Issued For:	Information
Rev:	-

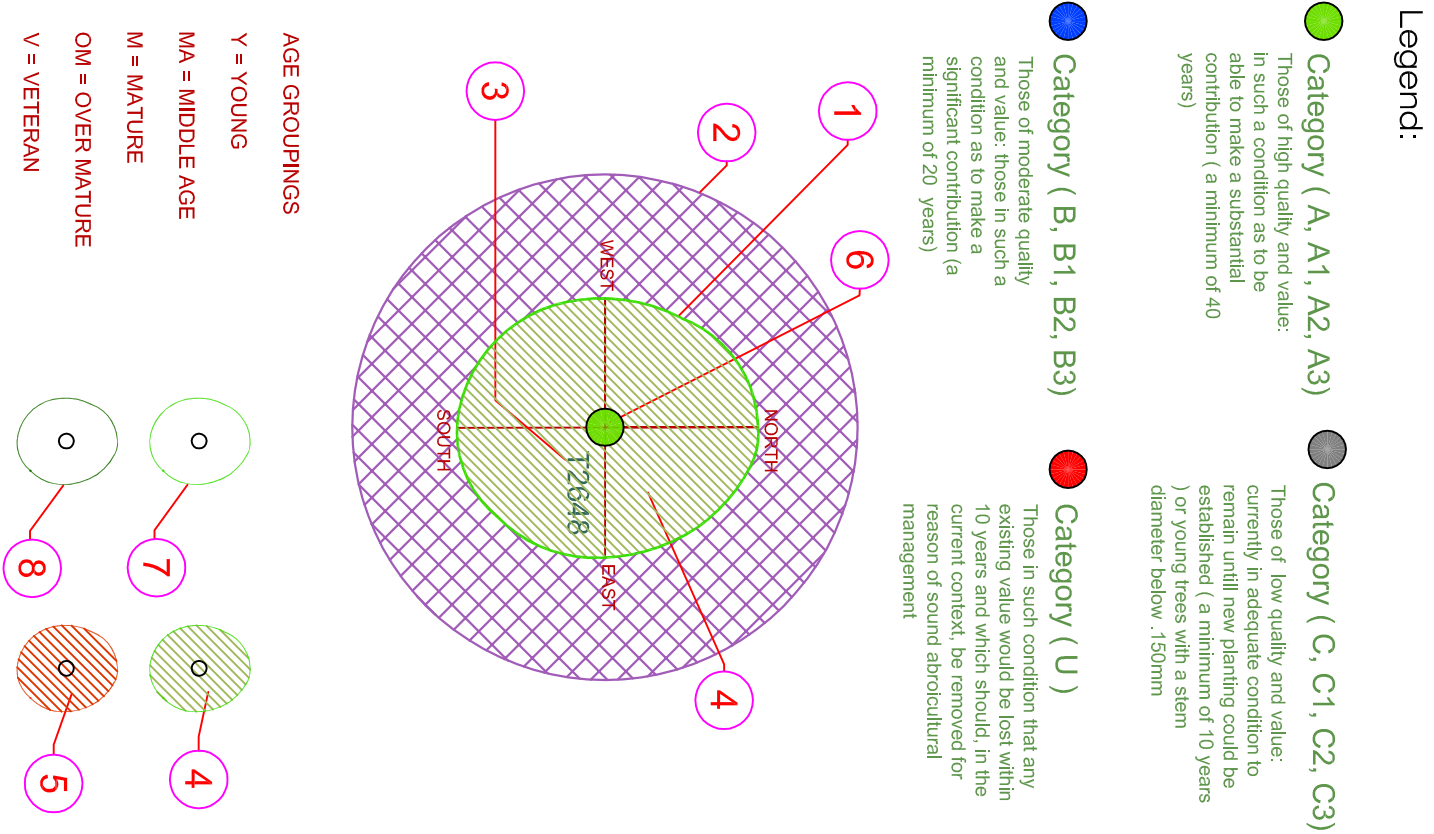
- EXISTING TREE CANOPY BASED ON DIMENSIONS GATHERED ON SITE IN 4 DIRECTIONS, NORTH, SOUTH, EAST AND WEST
 - ROOT PROTECTION ZONE BASED ON 12 TIMES THE DBH/AT CHEST HEIGHT
 - TREE TAG NUMBER
 - TREE TO BE RETAINED
 - TREE TO BE REMOVED
 - TREE CATEGORY BASED ON BS:5837 2012 CRITERIA
 - DECIDUOUS TREE CANOPY
 - EVERGREEN TREE CANOPY
- 01 TABLES BS 5837-2012

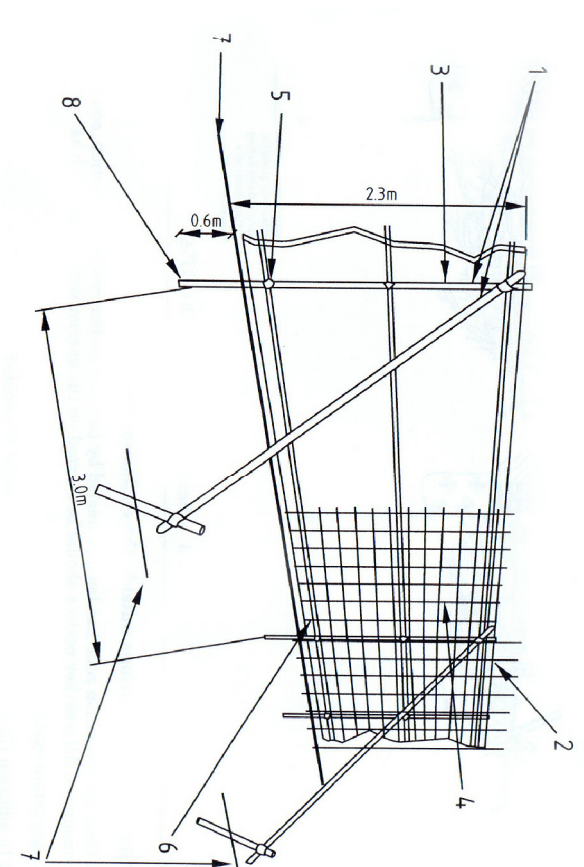
- Standard scaffold poles
- Uprights to be driven into the ground
- Panels secured to uprights with wire ties and where necessary standard scaffold poles
- Wire mesh wired to the uprights and horizontals
- Standard clamps
- Wire twisted and secured on the inside of fencing to avoid easy dismantling
- Ground level
- Approx. 0.6m driven into the ground

The above displays an example of a suitable protective barrier as recommended by BS 5837 2012 *Trees in Relation to Construction*

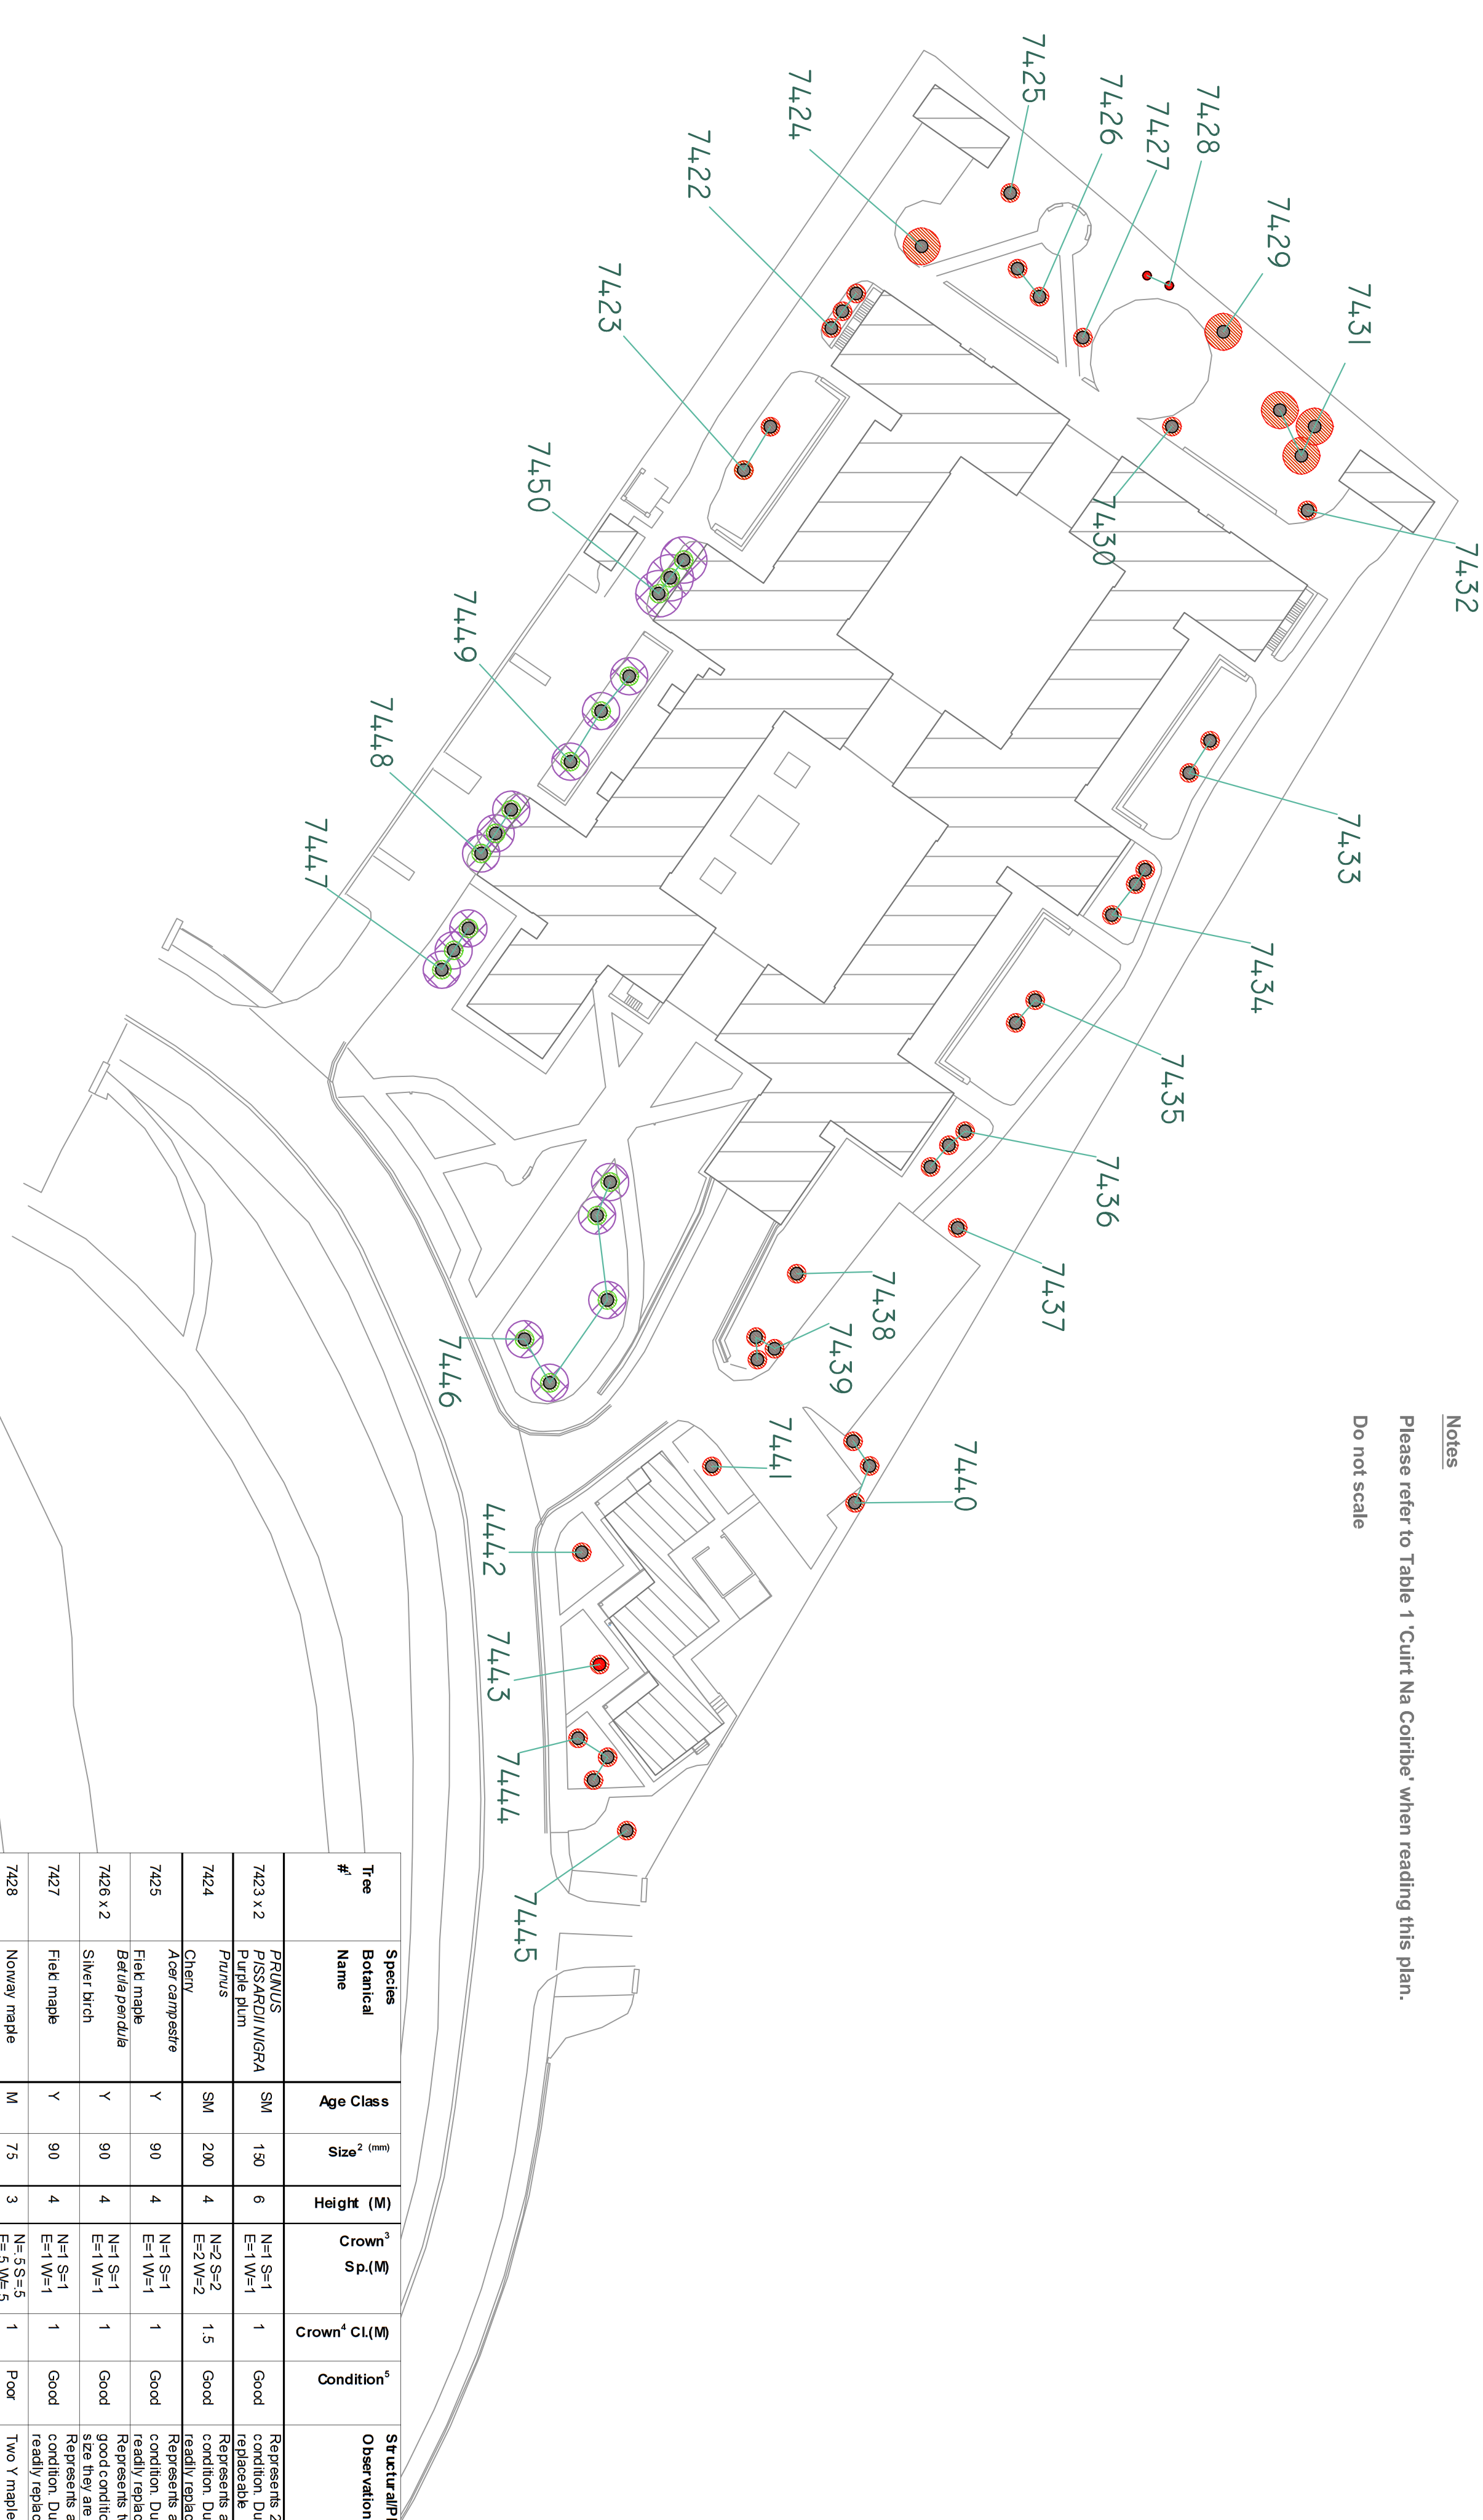
Please refer to Table 1 'Cuirt Na Coiribe' when reading this plan.
